# DAM SAFETY INSPECTION REPORT

Margaret Creek Structure No. 5

File Number: 9220-002

Inspection Date: May 23, 2007

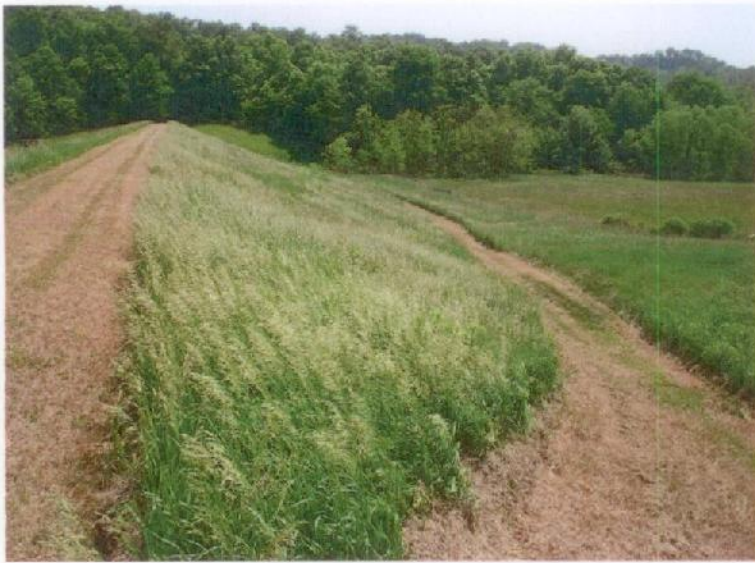
Photograph No. 1: The crest and downstream slope of the dam. Note the tall grass.

Tall grass on entire slope.

Mow the embankment and emergency spillway at least twice per year.

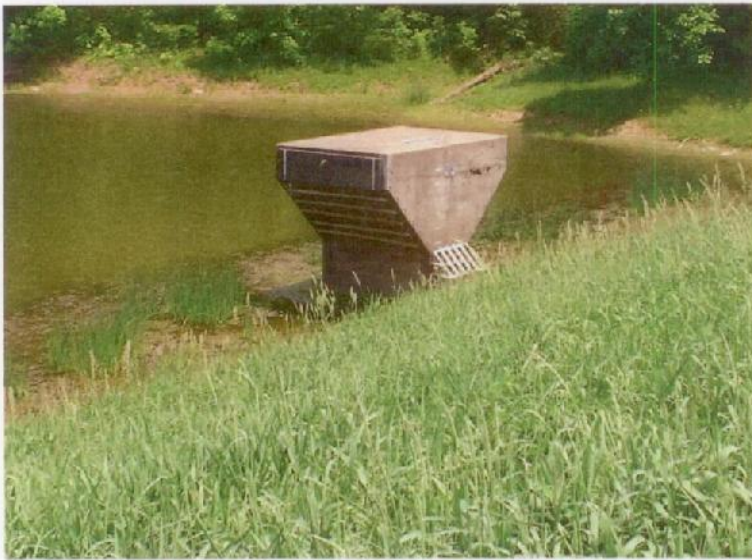
Photograph No. 2: The principal spillway riser.

Sediment & debris around low-flow inlet - appears to be beaver activity.

Remove debris from the inlet of principal spillway. Continue to remove beaver obstructions.

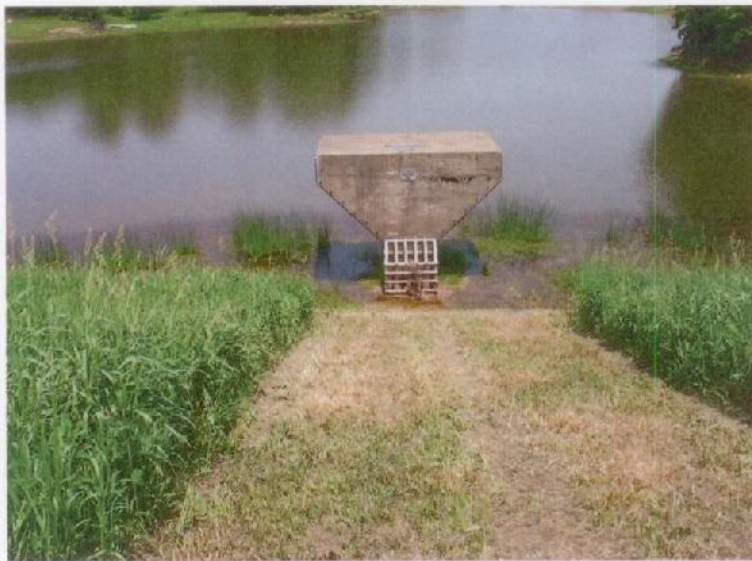
Photograph No. 3: The principal spillway riser.

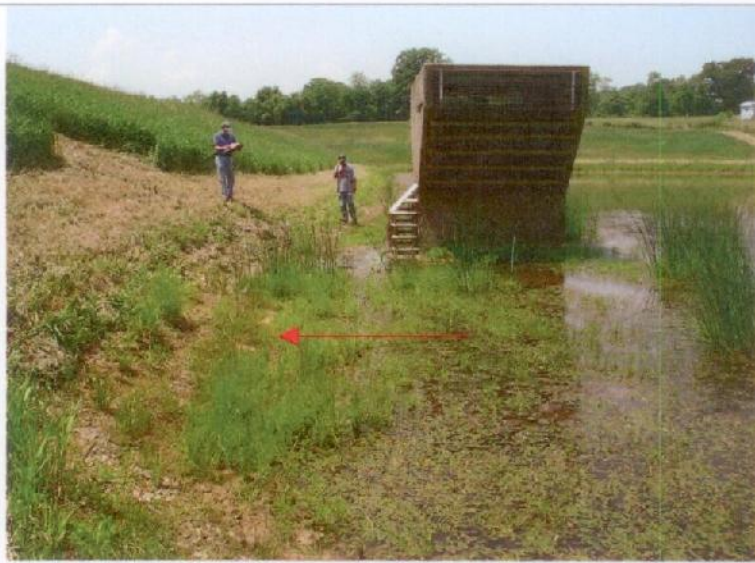
Photograph No. 4: The principal spillway riser. Note the indentation on the upstream slope of the dam.

Indentation 50 ft. long, 1 ft. into embankment, 6 inches high, near principal spillway riser.

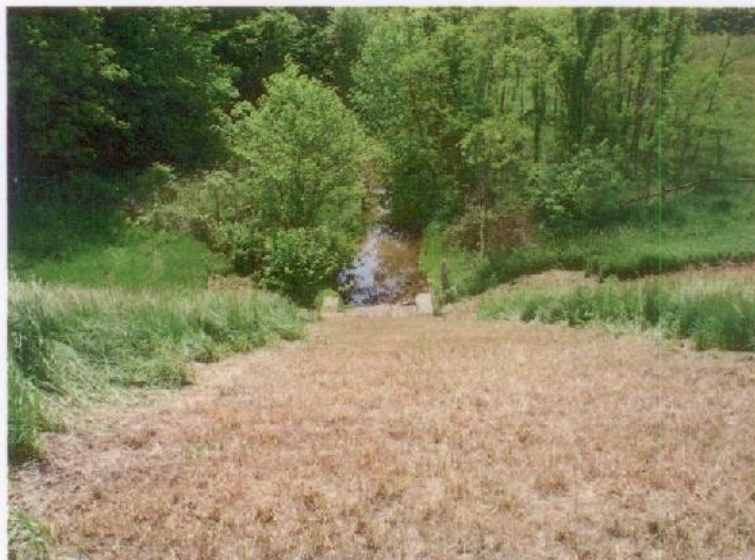
Photograph No. 5: Looking toward the principal spillway outlet from the crest of the dam.

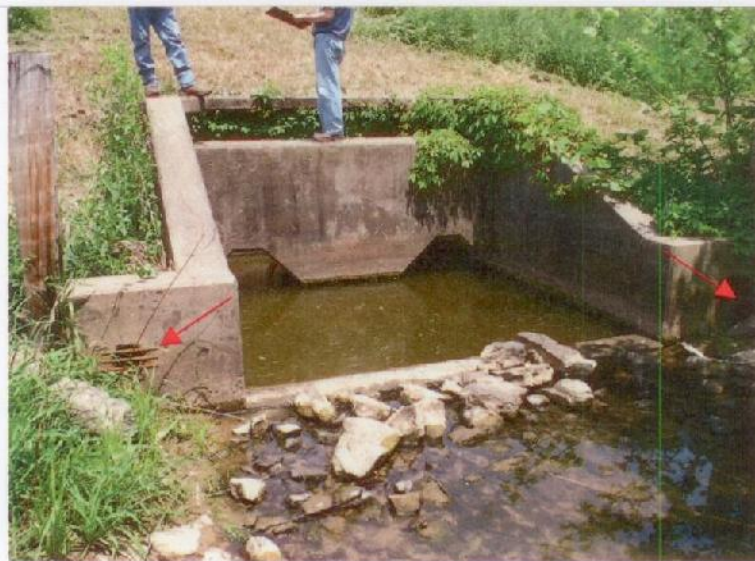
Photograph No. 6: The impact basin at the principal spillway outlet. Note the toe drain outlets.

No flow in toe drain outlets.  
 A small amount of rust colored deposits at outlet areas.

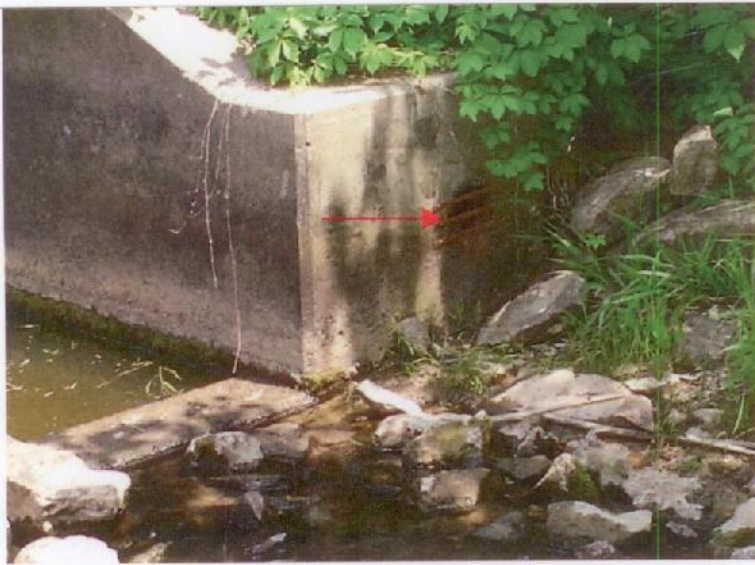
Photograph No. 7: The left toe drain outlet.

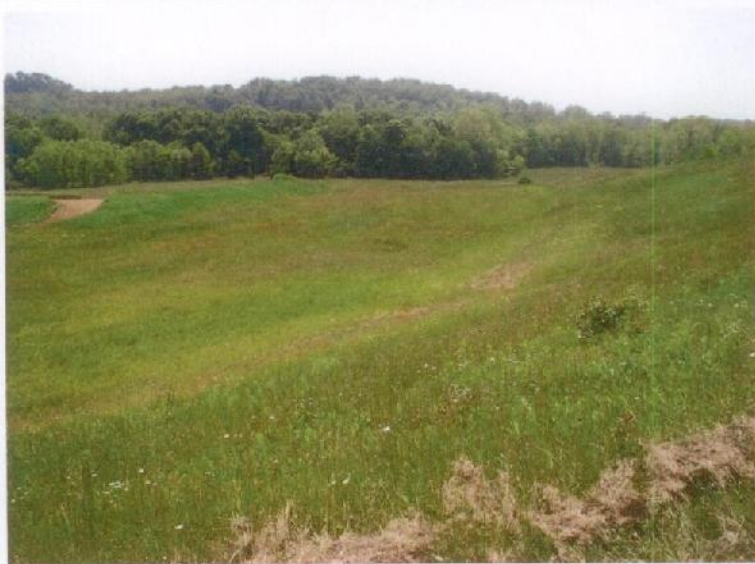
Photograph No. 8: The emergency spillway channel looking downstream.

No problems noted.

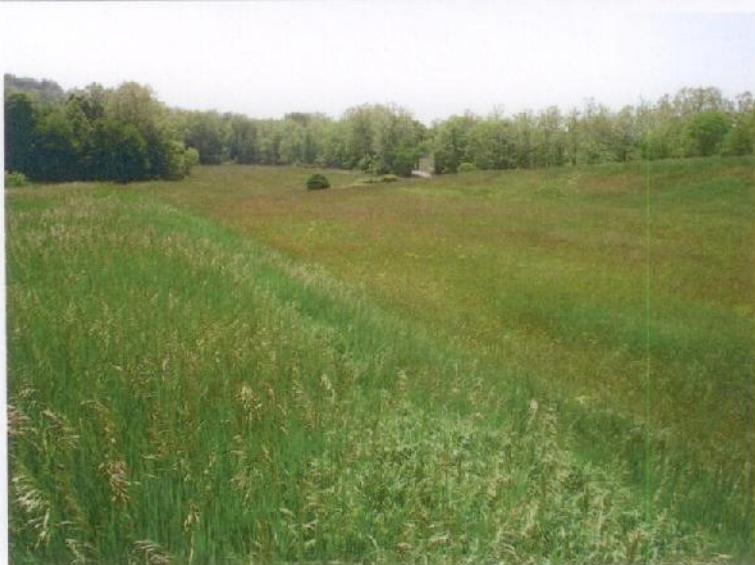
Photograph No. 9: The principal spillway channel looking downstream.
