DAM SAFETY INSPECTION REPORT

Margaret Creek Structure No. 1

File Number: 9121-008

Inspection Date: May 23, 2007

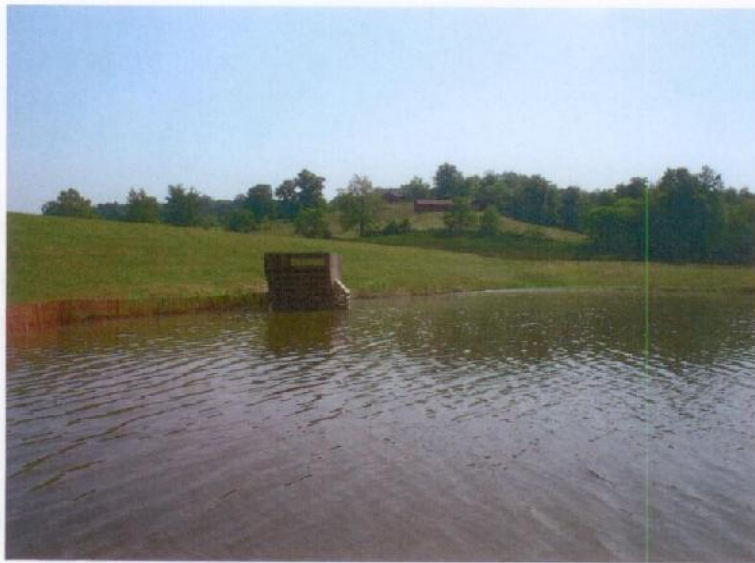
Photograph No. 1: The upstream slope of the dam.

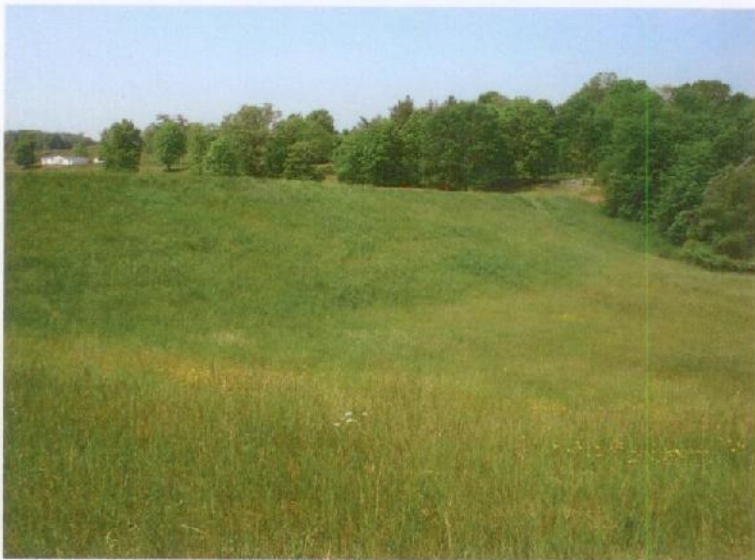
Photograph No. 2: The downstream slope of the dam.

1. Mow all vegetation on the embankment and in the emergency spillway at least twice per year. See the "Ground Cover" fact sheet included in this section for additional information.
2. Remove the vegetation from the concrete slabs adjacent to the stilling basin. See the "Trees and Brush" fact sheet included in this section for additional information.
3. Perform routine maintenance on the toe drains including clearing the pipe outlets. See the "Seepage Through Earthen Dams" fact sheet included in this section for additional information.

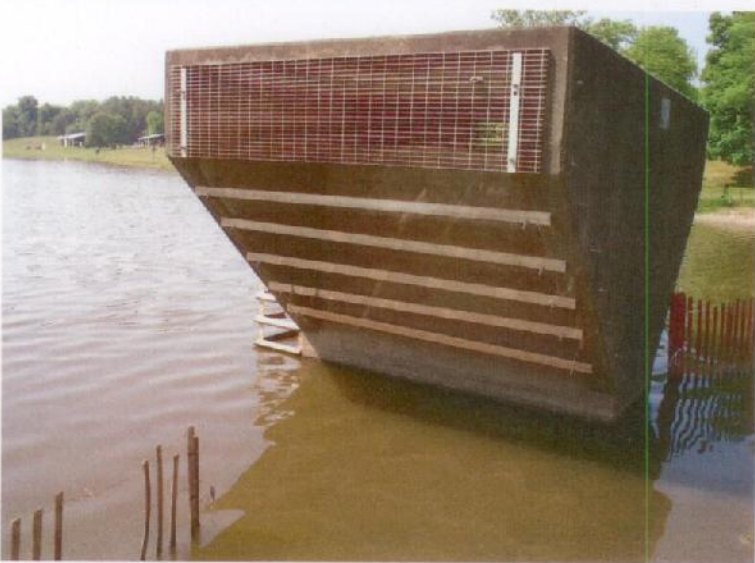
Photograph No. 3: The principal spillway riser.

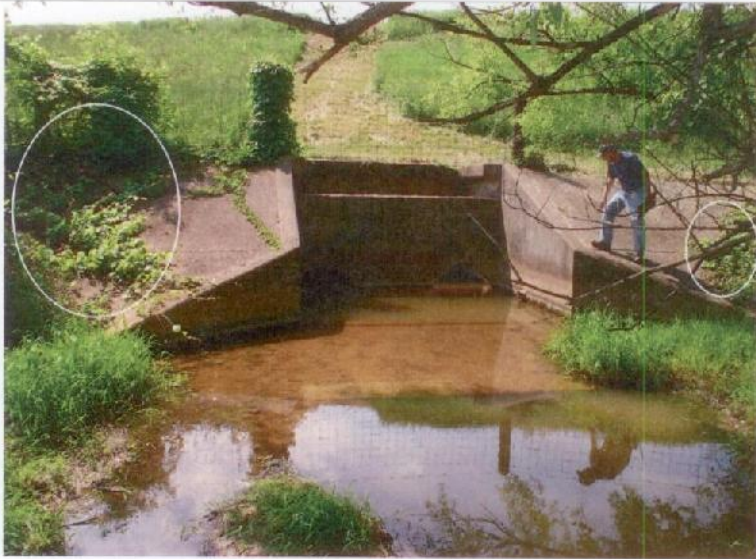
Photograph No. 4: The impact basin at the principal spillway outlet. Note the vegetation on the concrete surfaces.

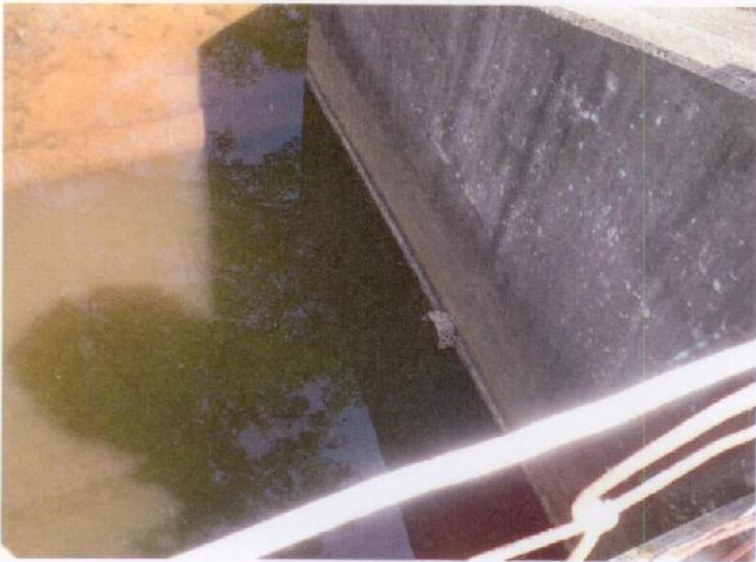
Photograph No. 5: The toe drain outlet on the right side of the impact basin. Note the rusted out invert.

Notes: INVERTS RUSTED OUT.
NEED TO BE CLEANED OUT DURING DRY PERIOD.

4. Monitor the condition of the toe drain outlet pipes. See the "Problems with Metal Materials" fact sheet included in this section for additional information.

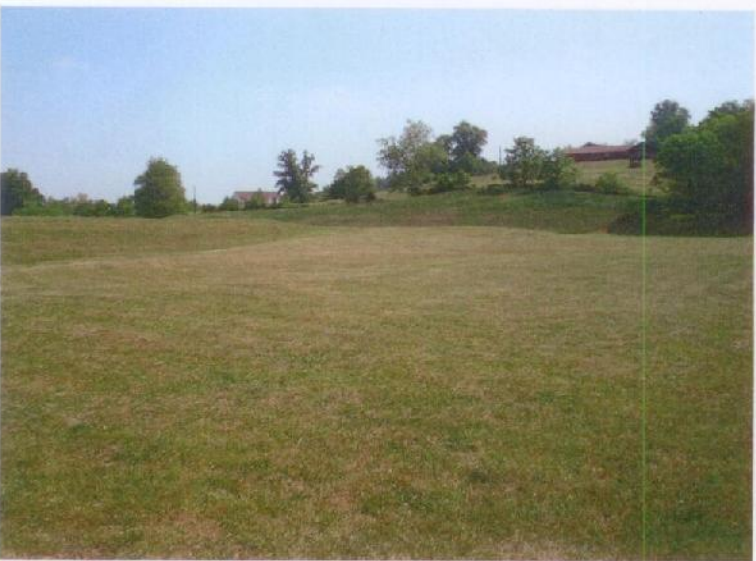
Photograph No. 6: The emergency spillway channel looking downstream.
