DAM SAFETY INSPECTION REPORT

Margaret Creek Structure No. 4

File Number: 9220-003

Inspection Date: 5/23/2007

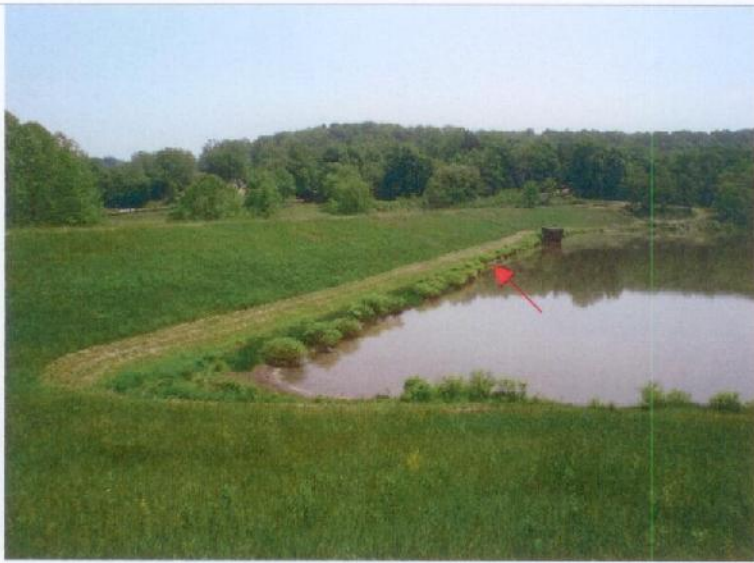
Photograph No. 1: The upstream slope of the dam. Arrow indicates approximate area of minor depression on the slope.

Depression 200 feet left of spillway, 10 feet long, 1 foot deep, may be a collapsed muskrat burrow.

- The embankment crest must have a uniform elevation. Repair the low area on/near...
- Rodent burrows weaken dam embankments and must be repaired. Rodent activity must be controlled.
Repair the muskrat damage to the upstream slope.
Fill the rodent burrows on (*entire embankment, crest, upstream slope, downstream slope*).

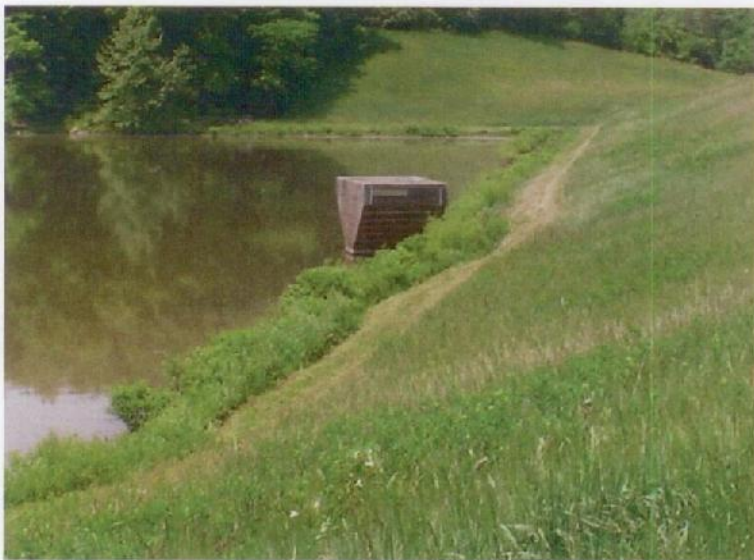
Photograph No. 2: The upstream slope and the principal spillway inlet. Note the brush along the shoreline.

Brush near shoreline.

- No owner repairs for this report.
- Brush is not permitted on embankment surfaces or earthen spillways. Remove brush from the shoreline on the upstream slope.

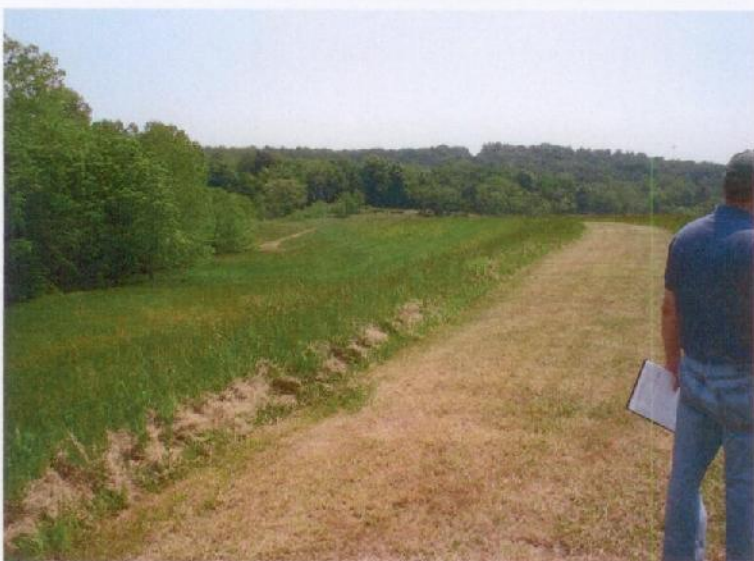
Photograph No. 3: The crest and the downstream slope of the dam.

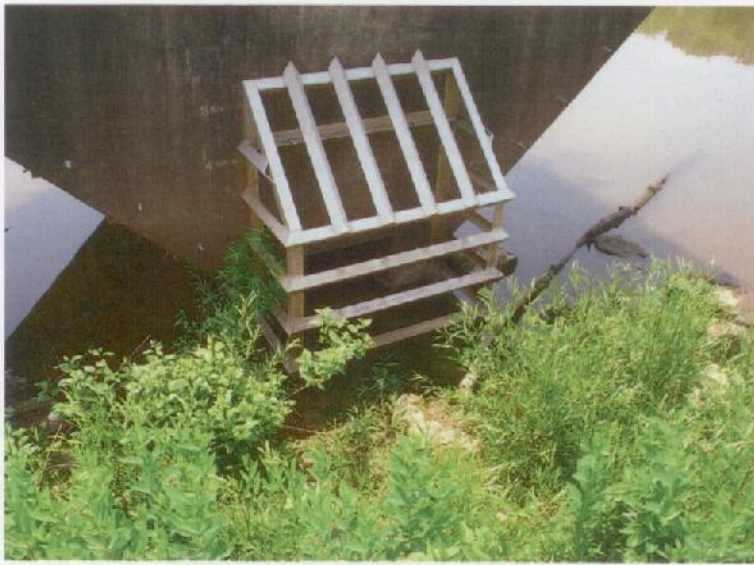
Photograph No. 4: The low-flow inlet of the principal spillway riser.

Low-flow inlet located on upstream side of riser

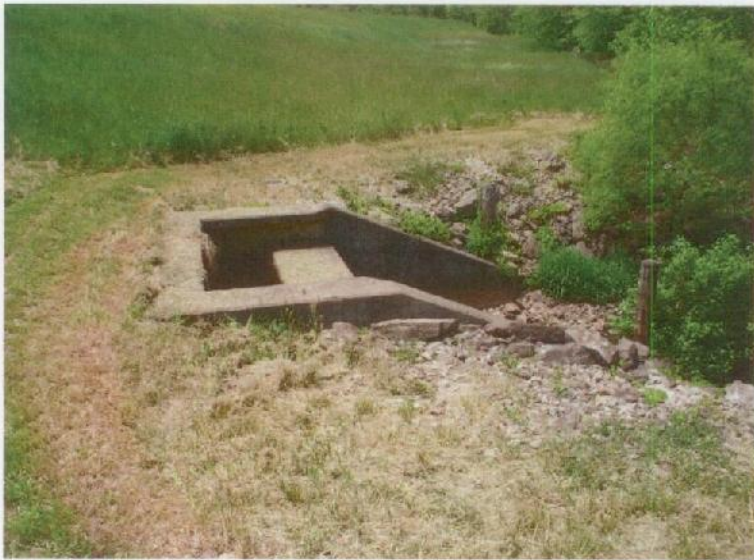
Photograph No. 5: The impact basin at the principal spillway outlet.

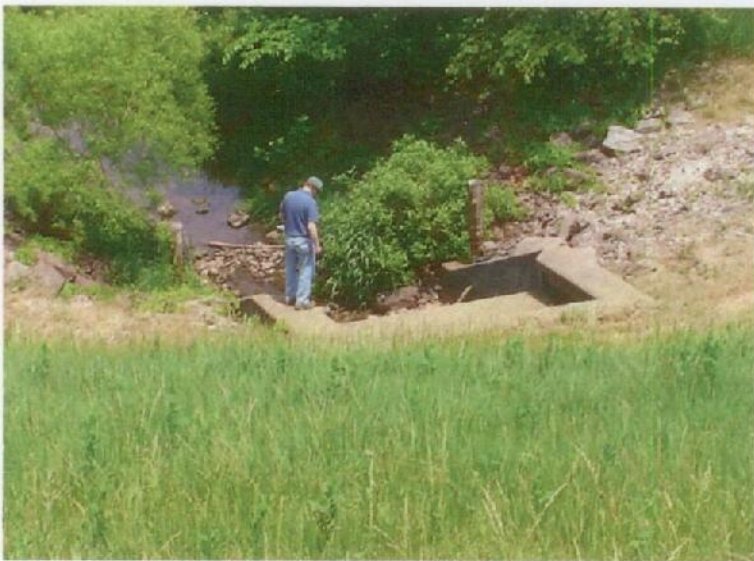
Photograph No. 6: The impact basin at the principal spillway outlet.

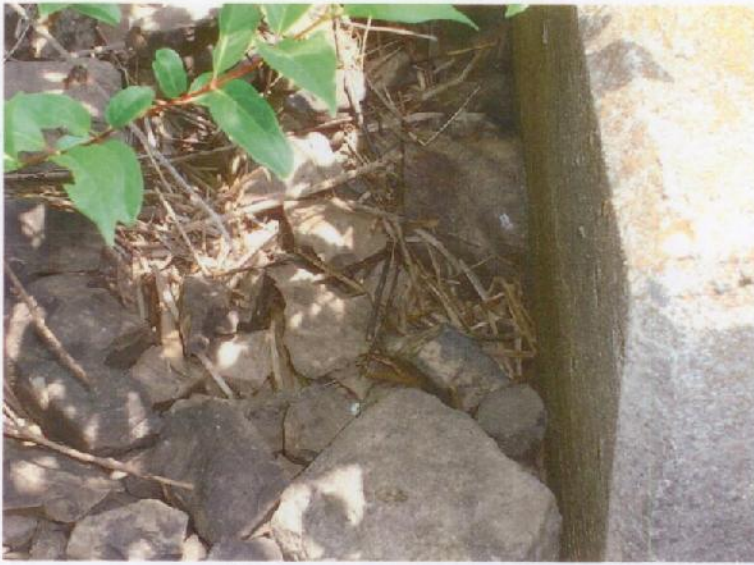
Photograph No. 7: The toe drain outlet.
Note the rocks covering the outlet.

No flow in toe drain.
 Rocks covering toe drain outlets

- Embankment drains and spillway drains must be periodically maintained to ease monitoring and functionality. Pipe outlets should be marked and cleared regularly to allow the owner to quickly identify changing seepage conditions in the dam. Remove the rocks covering the toe drain outlets.

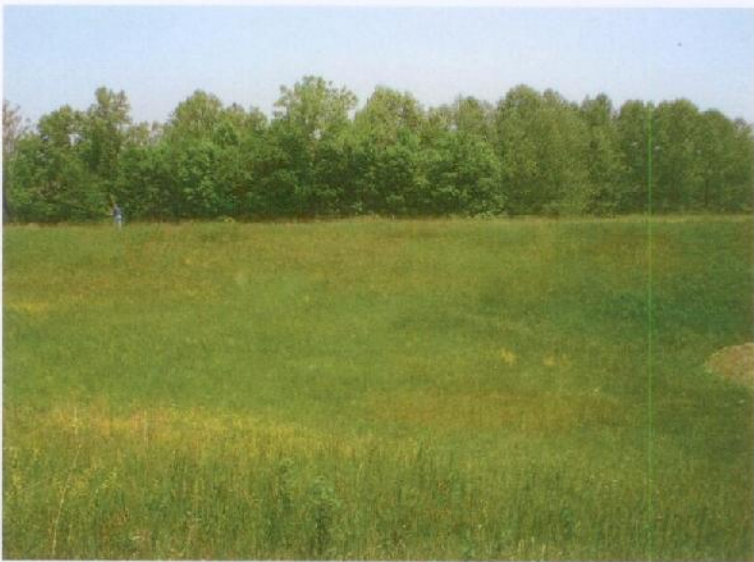
Photograph No. 8: The inlet of the
emergency spillway channel.

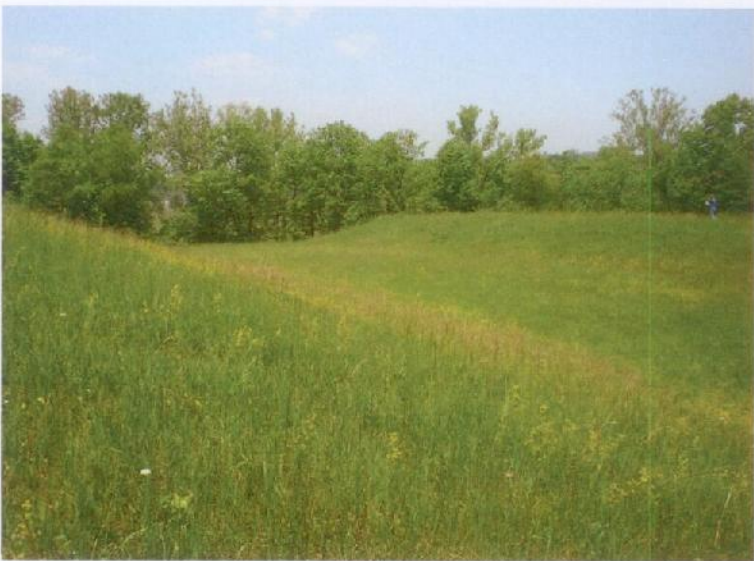
Photograph No. 9: The emergency
spillway channel looking downstream.

Tall grass in entire channel
