DAM SAFETY INSPECTION REPORT

Margaret Creek Structure No. 6
File Number: 9221-001

Athens County, Waterloo Township
Inspection Date: May 23, 2007

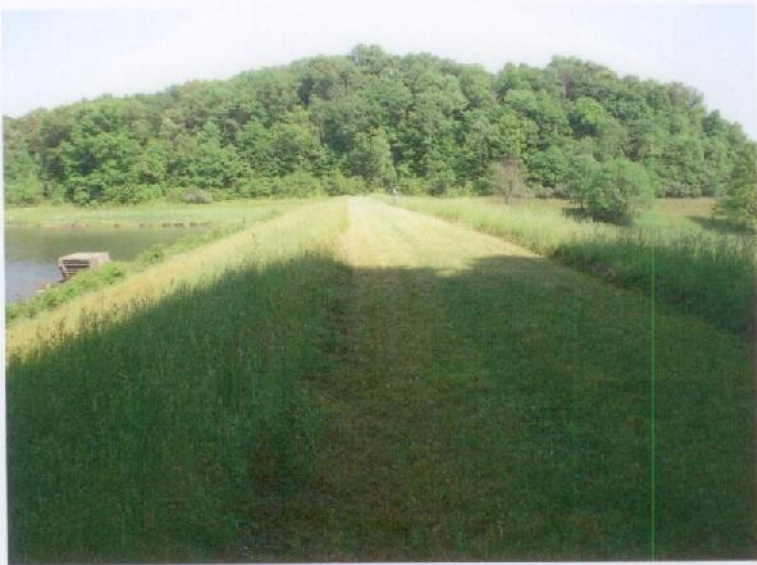
Photograph No. 1: The upstream slope and crest of the dam viewed from the right abutment.

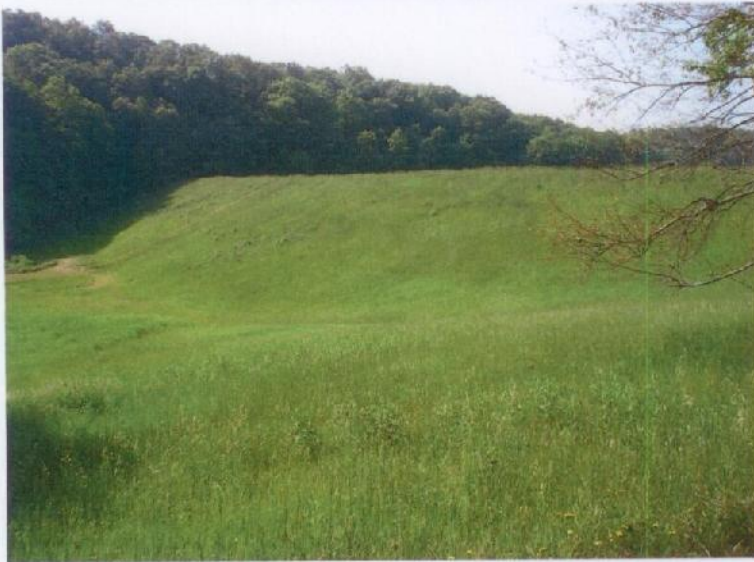
Photograph No. 2: The downstream slope of the dam viewed from the left abutment.

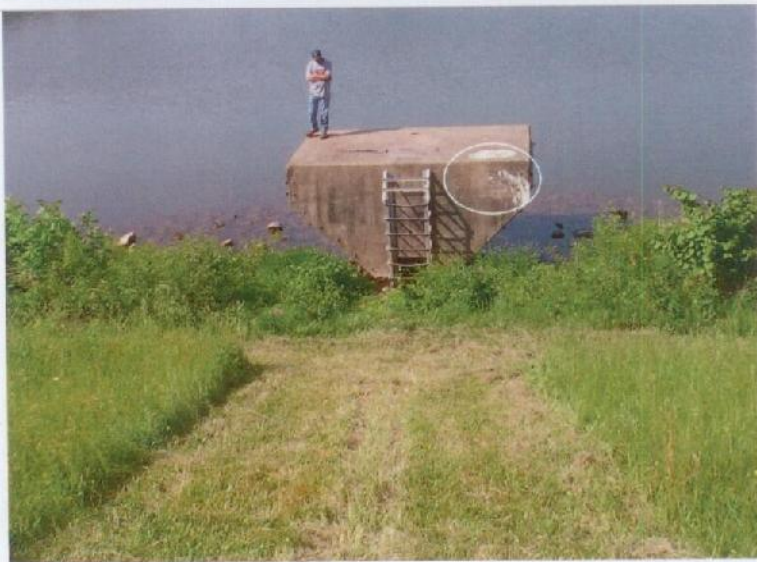
Photograph No. 3: The principal spillway riser. Note the cracking and efflorescence.

3. Monitor the condition of the spillway riser and the concrete cradle at the outlet yearly for further cracking and efflorescence. See Photograph No. 3. See the "Problems with Concrete Materials" fact sheet included in this section for guidance in monitoring the spillway system and for additional information.

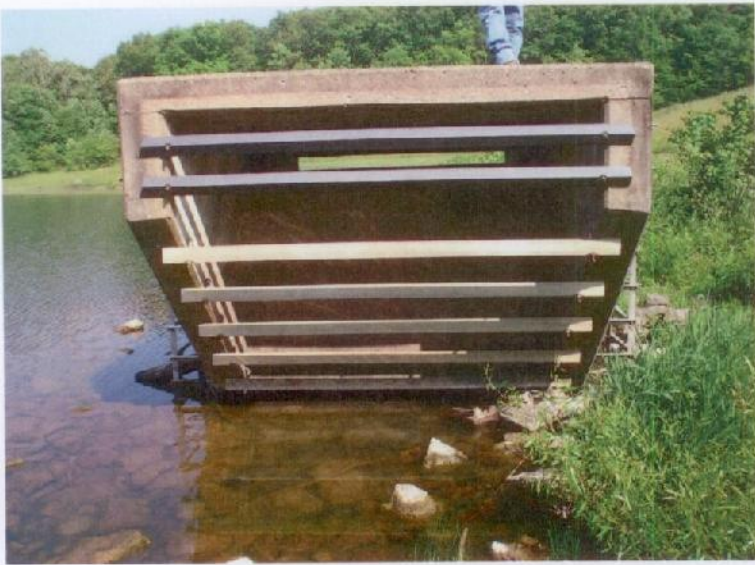
Photograph No. 4: The principal spillway riser.

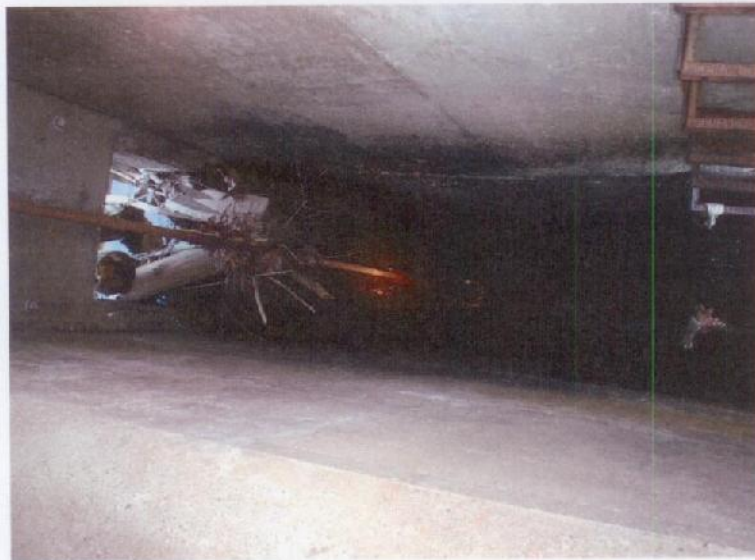
Photograph No. 5: The interior of the principal spillway riser. Note the debris at the low-flow inlet.

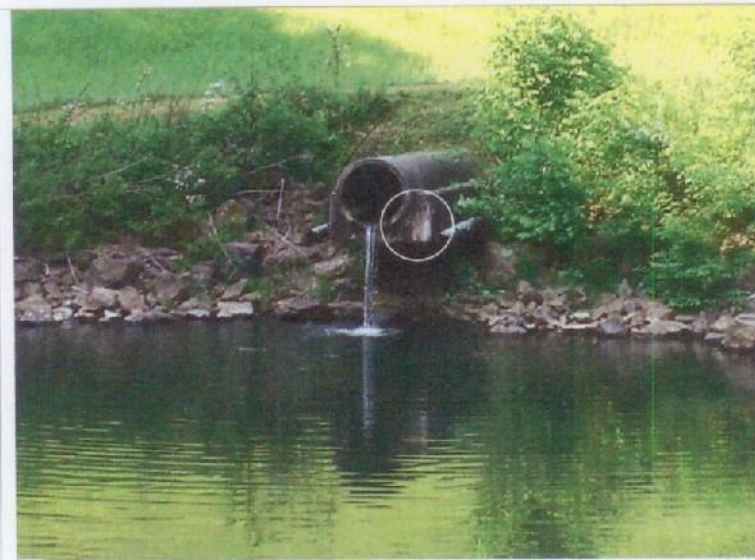
Photograph No. 6: The outlets of the principal spillway pipe and the toe drains. Note the cracks and efflorescence on the concrete cradle.

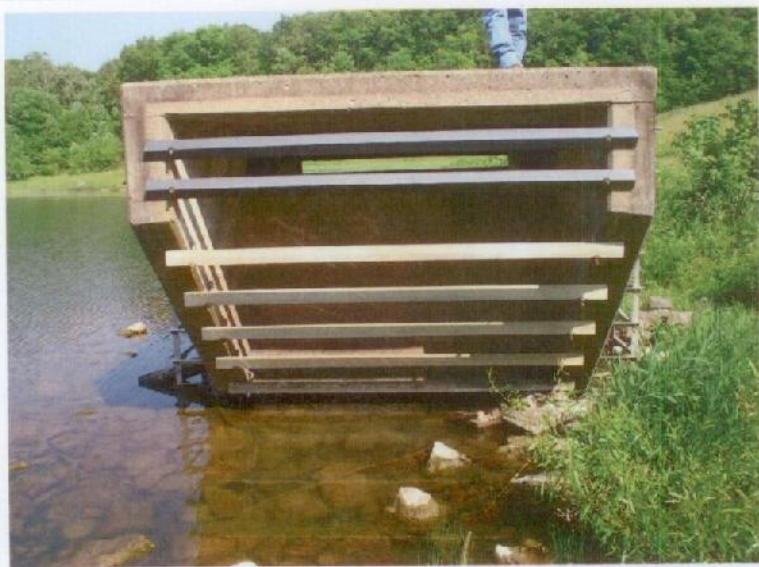
Photograph No. 4: The principal spillway riser.

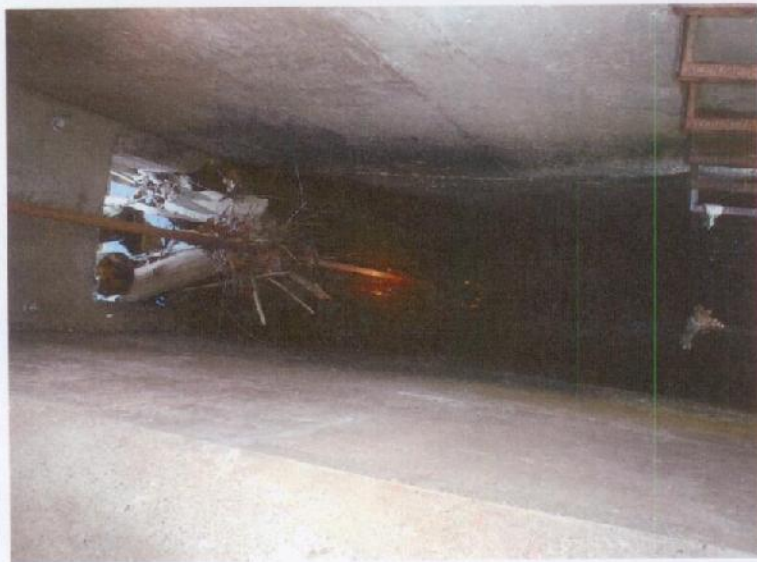
Photograph No. 5: The interior of the principal spillway riser. Note the debris at the low-flow inlet.

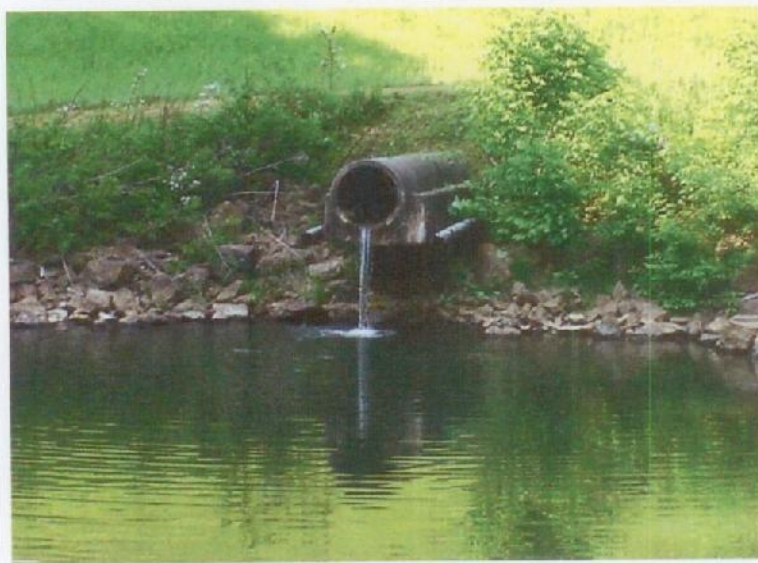
Photograph No. 6: The outlets of the principal spillway pipe and the toe drains.

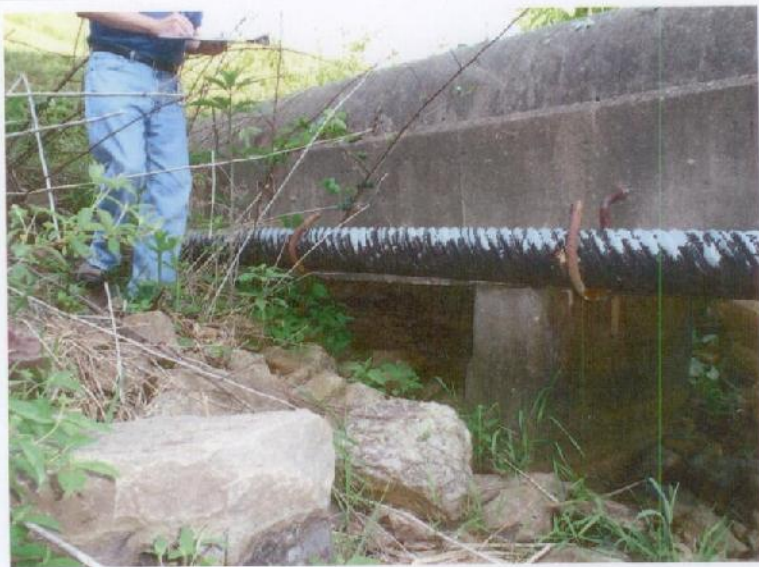
Photograph No. 7: The support for the principal spillway outlet pipe.

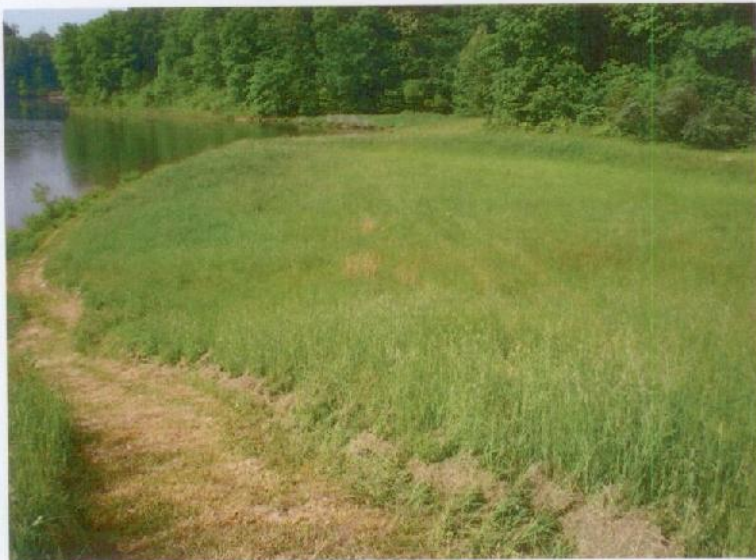
Photograph No. 8: The inlet of the emergency spillway channel.

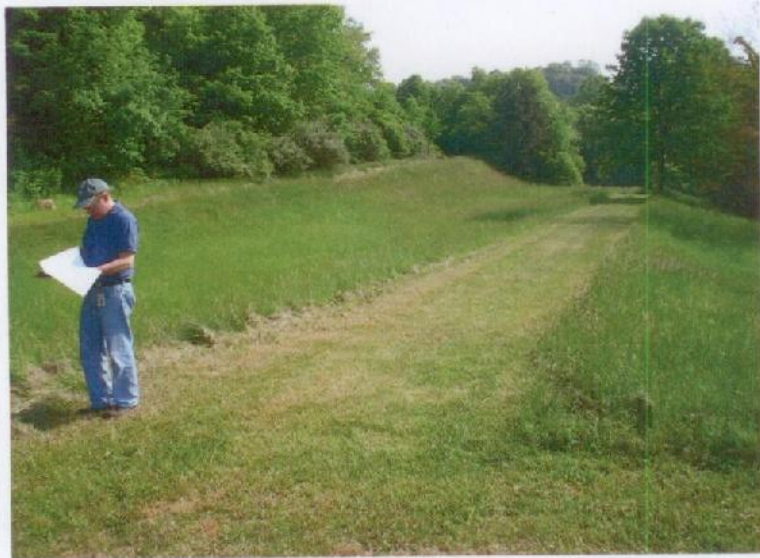
Photograph No. 9: The emergency spillway channel looking downstream.
