Rehabilitation Assessment Report
Margaret Creek Site 1 – Meeks Lake
Athens County, Ohio

Prepared by: Natural Resources Conservation Service
Columbus, Ohio
September 2010

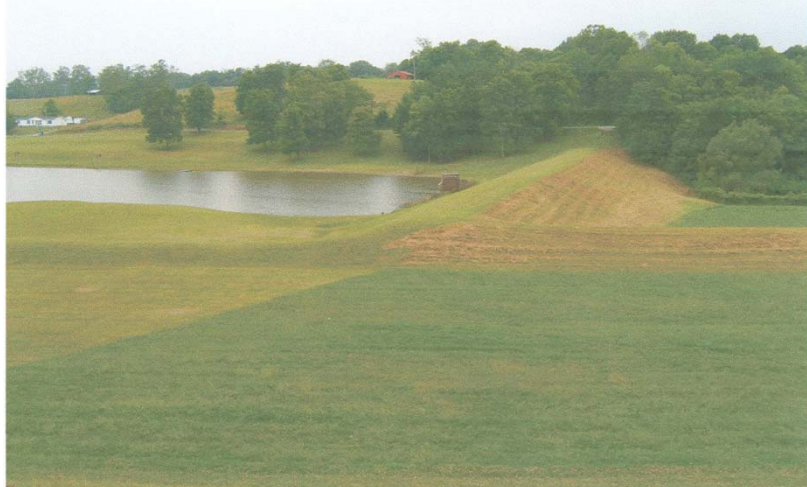
<p>Looking West from Auxiliary Spillway to Pool and Dam Embankment.</p>

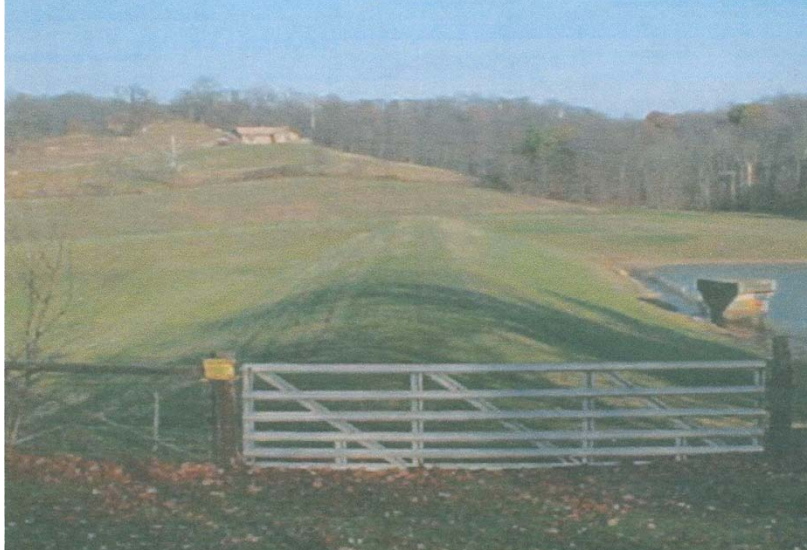
<p>Looking East from Hebbardsville Road (County Road 19) toward Principal Spillway Riser and Dam Embankment with Auxiliary Spillway in the background.</p>

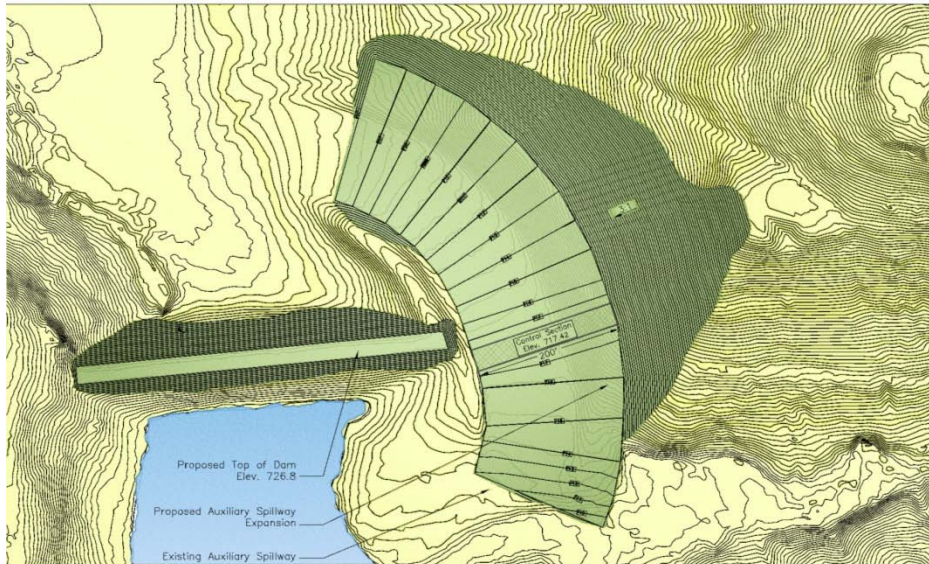
Figure 3 – Auxiliary Spillway modification

- 1. Alternative 1** – This alternative widens the auxiliary spillway from 120 feet to 200 feet and raises the top of dam 3.4 feet to elevation 726.8. Widening the auxiliary spillway to 200 feet is about the maximum feasible from the standpoint of the available room on the right abutment before getting too close to an existing house. Therefore, this alternative minimizes the rise in the top of dam obtainable from widening the existing auxiliary spillway. (There is a county road close by on the left side, opposite the existing auxiliary spillway, which precludes adding a second auxiliary spillway in the left abutment.)

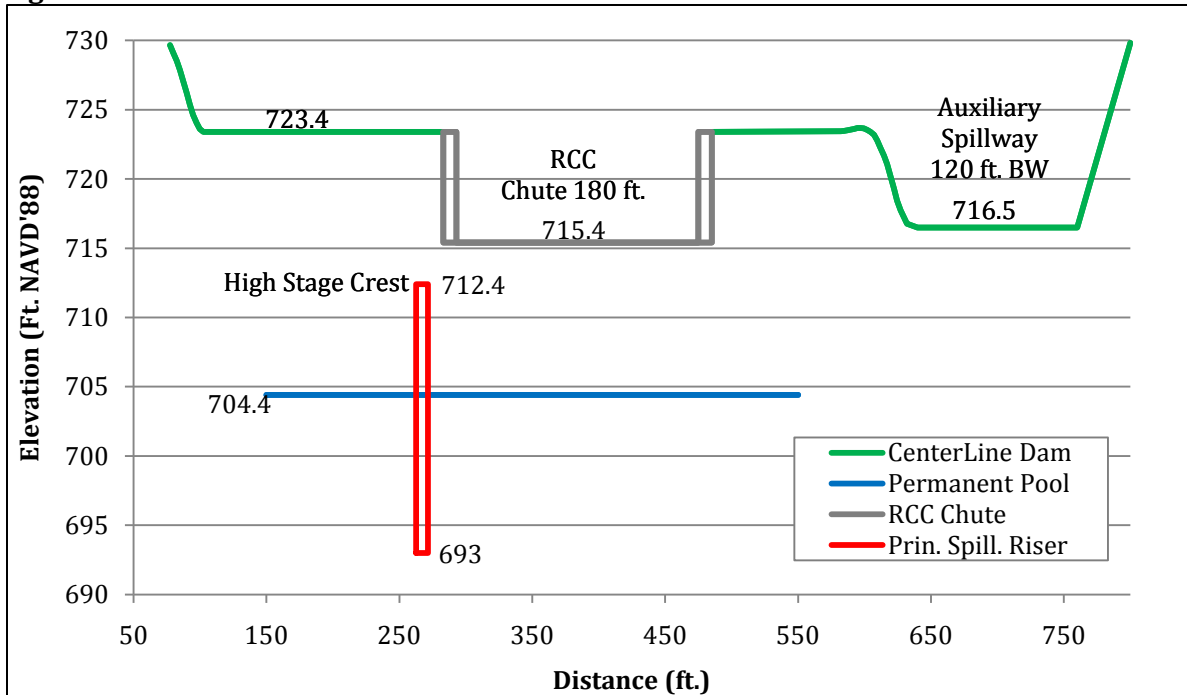
Figure 4 – Schematic of RCC Chute in Embankment of Dam

- Alternative 3** – This alternative uses a 180 foot wide Roller Compacted Concrete (RCC) chute placed in the existing dam at elevation 715.4 (1 foot below existing auxiliary crest) and thereby removes the need to raise the dam. This width should fit in the embankment on the east side of the principal spillway. This would be an 8 foot deep cut through the existing embankment, with a crest 11 feet above the permanent pool elevation and 3 feet above the principal spillway high stage crest. The existing vegetative auxiliary spillway will remain at 120 foot bottom width although it needs to be raised 0.1 foot to elevation 716.5. (To be able to leave the existing vegetative spillway at its present elevation requires the RCC to be put 0.2 feet lower at elevation 715.2. The downside to lowering the RCC spillway is that it allows greater discharges at lower frequency storms. This could be done but see the related discussion following.)
