DAM SAFETY INSPECTION REPORT

Margaret Creek Structure No. 1

File Number: 9121-008

Inspection Date: May 23, 2007

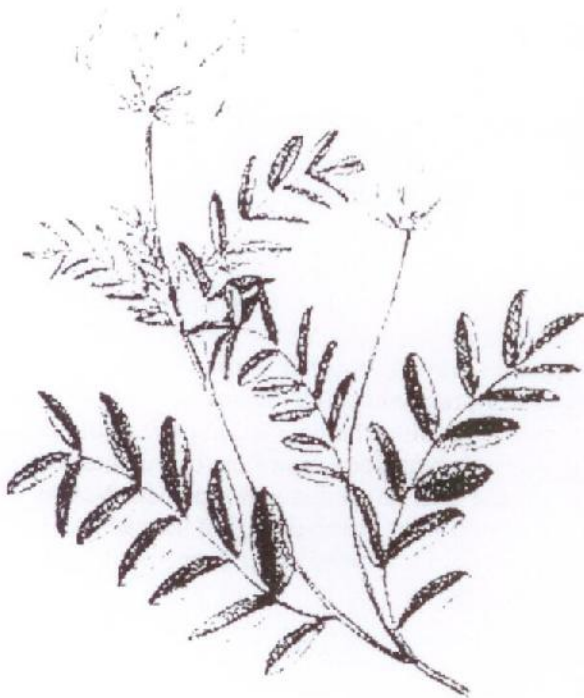
Figure 1: Crown Vetch
(Source: <http://www.vg.com>)

Crown vetch, a perennial plant with small pink flowers, has been used on some dams in Ohio but is not recommended (see Figure 1). It hides the embankment surface, preventing early detection of cracks and erosion. It is not effective in preventing erosion.

Vines and woody vegetation such as trees and brush also hide the embankment surface preventing early detection of cracks and erosion. Tall vegetation also provides a habitat for burrowing animals. All improper vegetation must be removed from the entire embankment surface. Any residual roots that are larger than 3 inches in diameter must be removed. All roots should be removed down to a depth of at least 6 inches and replaced with a compacted clay material; then 4 inches of topsoil should be placed on the disturbed areas of the slope. Finally, these areas must be seeded and mulched to establish a proper grass cover.

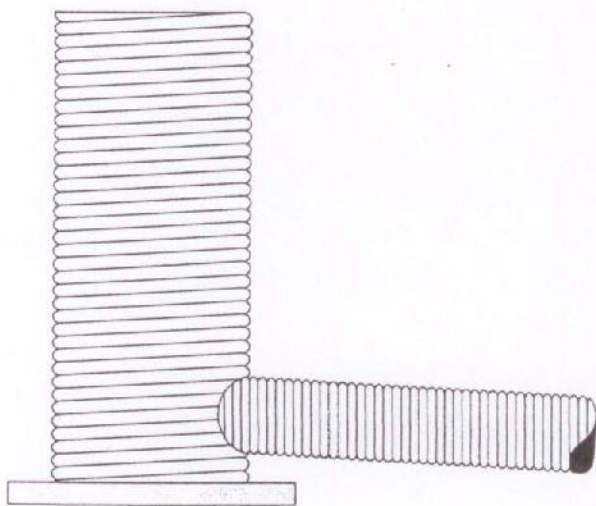
Figure 1 – Example of a corrugated metal pipe and riser spillway.

Corrosion is a common problem for spillway conduits and other metal appurtenances. Corrosion is the deterioration or breakdown of metal because of a reaction with its environment. Exposure to moisture, acidic conditions, or salt will accelerate the corrosion process. Acid runoff from strip-mined areas will cause rapid corrosion of metal conduits. In these areas, conduits made of less corrodible materials such as concrete or plastic should be used. Soil types also factor into the amount of corrosion. Clayey soils can be more corrosive than sandy soils since they are poorly drained and poorly aerated. Silts are somewhere in between clays and sands. Some examples of metal conduits include ductile iron, smooth steel, and corrugated metal. Corrugated metal pipe is not recommended for use in dams since the service life for corrugated metal is only 25 to 30 years, whereas the life expectancy for dams is much longer. In areas of acidic water, the service life can be much less. Therefore, corrugated metal spillway conduits typically need to be repaired or replaced early in the dam's design life, which can be very expensive.

Conduit coating is an effective way of controlling corrosion of metal conduits if used properly. It is relatively inexpensive and extends the life of the conduit. Some examples of coatings include cement-mortar, epoxy, aluminum, or polyethylene film. Asphalt (bituminous) coatings are not recommended since their service life is usually only one or two years. Coatings must be applied to the conduit prior to installation and protected to ensure that the coating is not scratched off. Coatings applied to conduits in service are generally not very effective because of the difficulty in establishing an adequate bond.
