DAM SAFETY INSPECTION REPORT

Margaret Creek Structure No. 4

File Number: 9220-003

Inspection Date: 5/23/2007

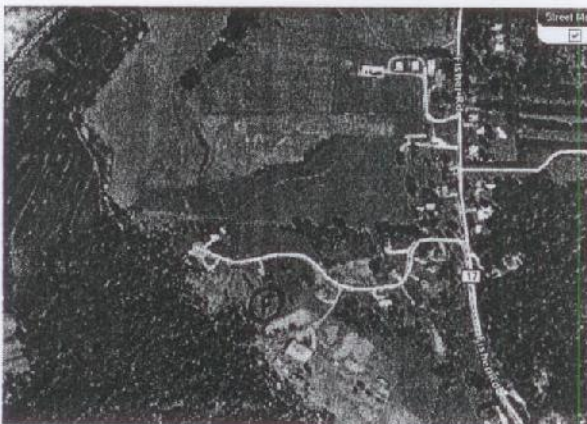
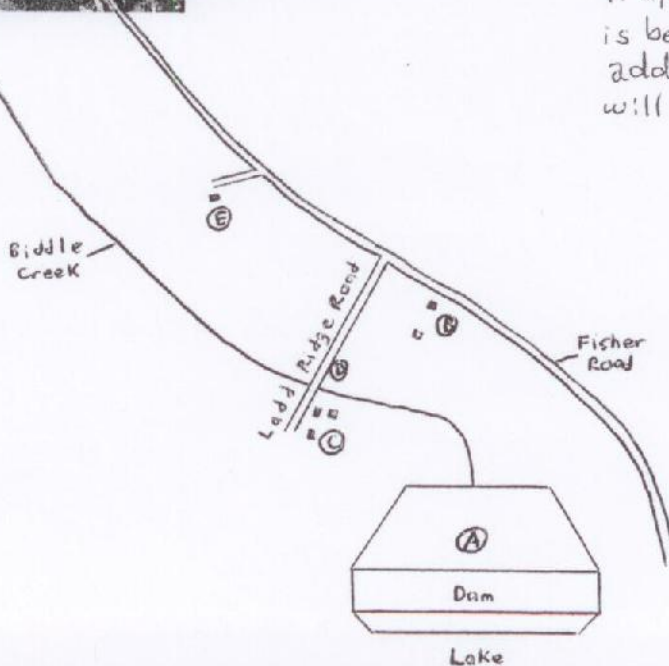
Sketch of Developments Downstream of Dam

B = Home & Garage
 C = Home & Garage
 D = Local Road
 E = Home & Garage
 F = Various Development

It appears that this area is being developed and additional structures will be constructed.

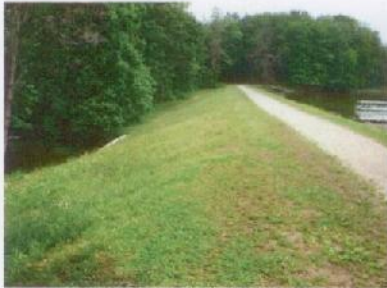
Dam embankment prior to severe flood.

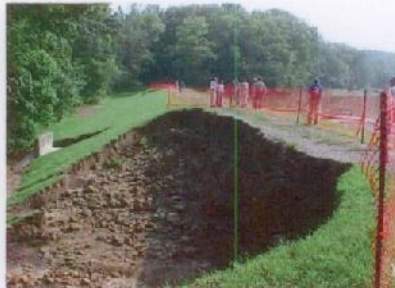
Erosion caused by floodwater overtopping the dam – a result of inadequate discharge/storage capacity.

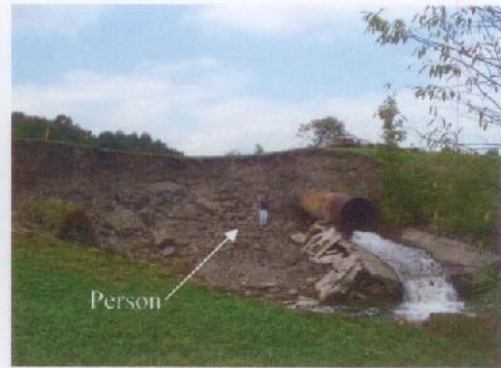
Erosion caused by floodwater overtopping the dam – a result of inadequate discharge/storage capacity and debris obstructing the 5-foot-diameter spillway pipe.
