DAM SAFETY INSPECTION REPORT

Margaret Creek Structure No. 6
File Number: 9221-001

Athens County, Waterloo Township
Inspection Date: May 23, 2007

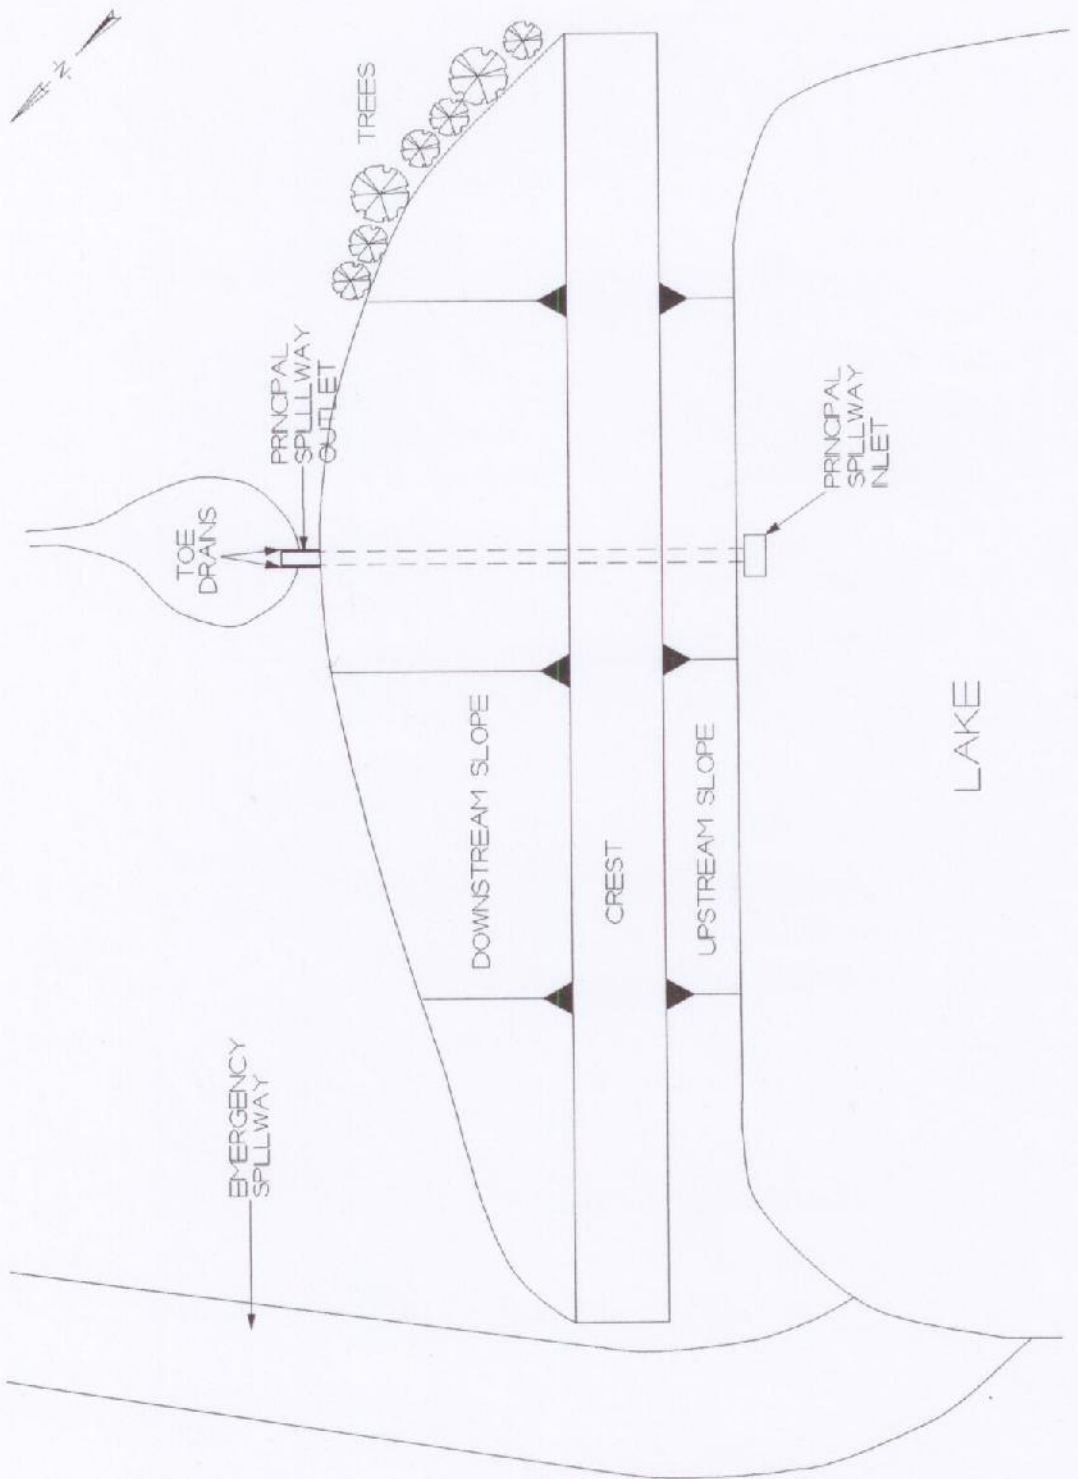
DAM SAFETY ENGINEERING PROGRAM	STATE OF OHIO DEPARTMENT OF NATURAL RESOURCES DIVISION OF WATER	MARGARET CREEK STRUCTURE NO. 6	DESIGNED BY: V.A.Z. DRAWN BY: V.A.Z. CHECKED BY: APPROVED BY:	FILE NO: 922-001 SCALE: NONE DATE: 6/27/07 REVISED:	DATE OF INSPECTION: MAY 23, 2007
